# Aviation Investigation Preliminary Report

| <b>Location:</b> | Louisville, KY | <b>Accident Number:</b> | DCA26MA024 |
| <b>Date &amp; Time:</b> | November 4, 2025, 17:14 Local | <b>Registration:</b> | N259UP |
| <b>Aircraft:</b> | McDonnell Douglas MD-11F | <b>Injuries:</b> | 14 Fatal, 2 Serious, 21 Minor |

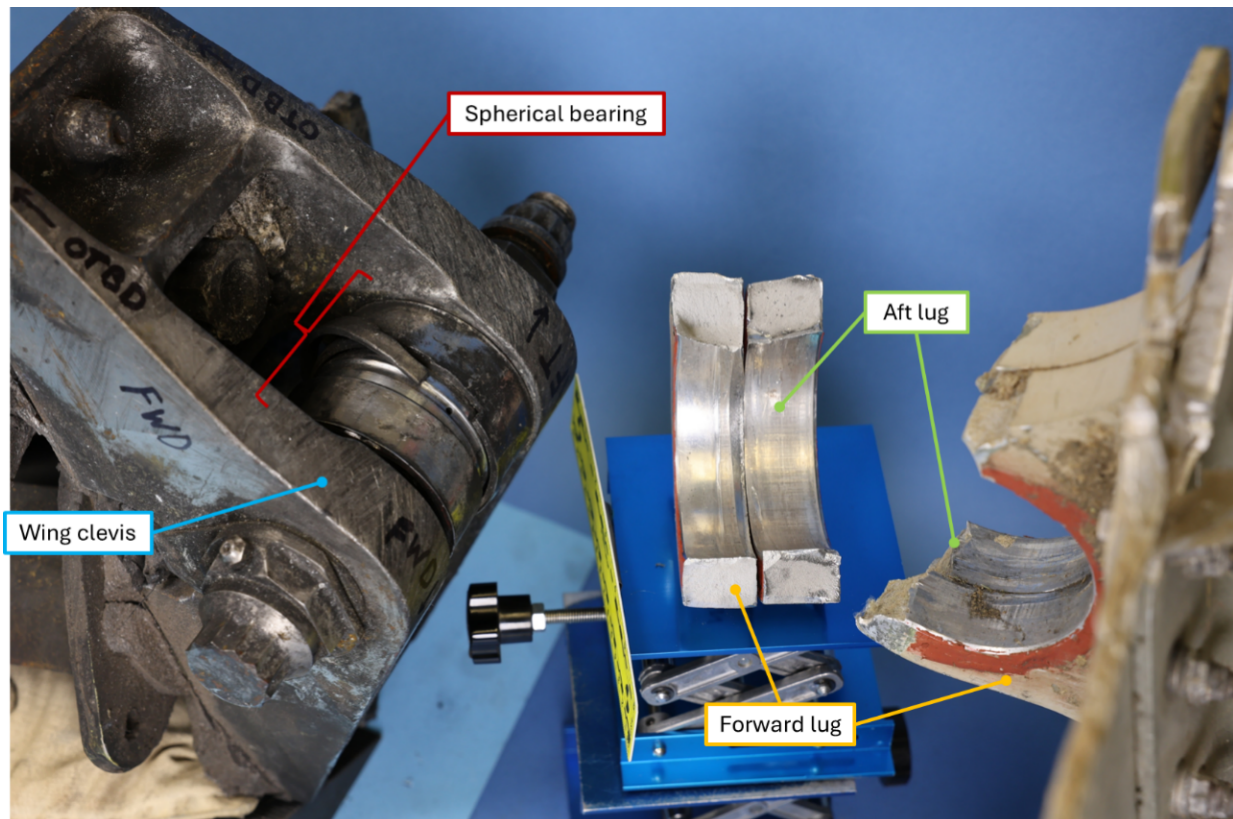
The left pylon aft mount, fractured lugs from the left pylon aft mount, and the left wing clevis (containing the aft mount spherical bearing and attachment hardware) were retained for further examination at the NTSB Materials Laboratory (see figure 9). The right pylon aft mount and wing clevis assembly as well as two engine fan blade fragments found on runway 17R were also retained for further examination at the NTSB Materials Laboratory.

**Figure 9.** The left pylon aft mount, the fractured and separated forward and aft lugs, and the left wing clevis containing the attachment hardware and fractured spherical bearing.

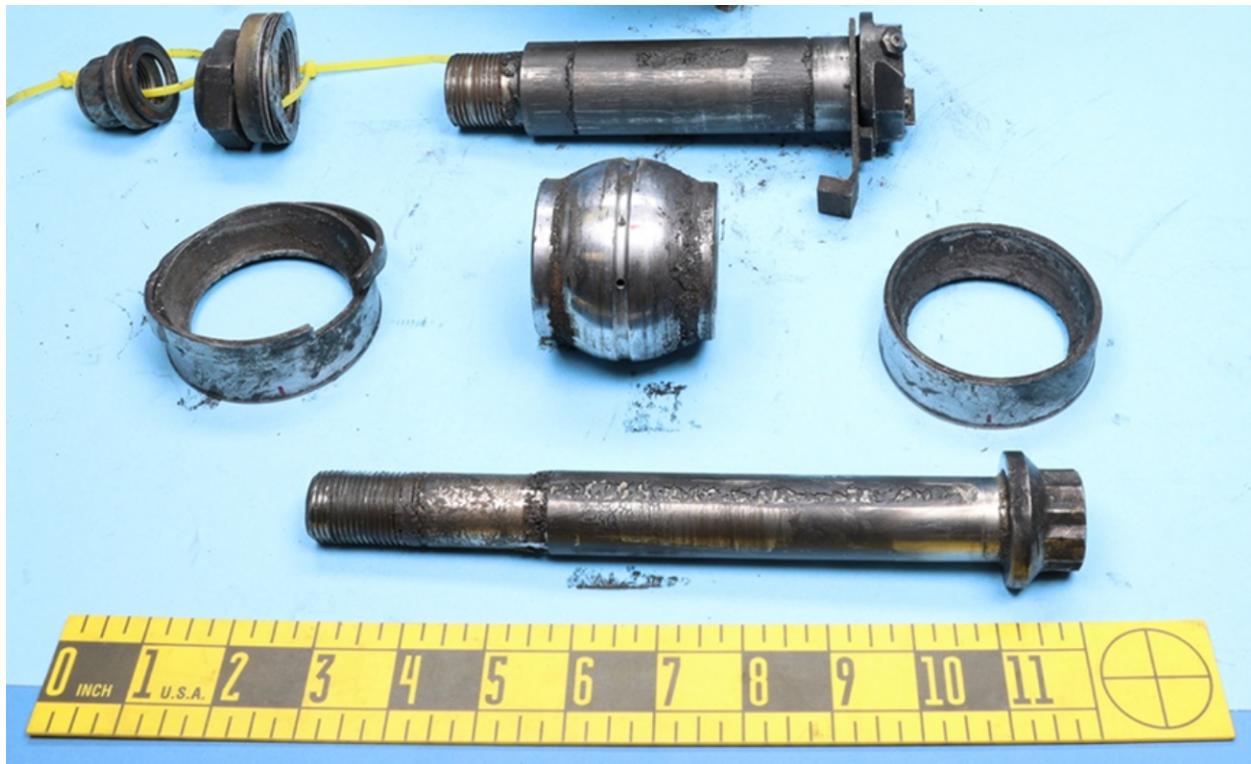
After initial cleaning of the fracture surfaces, examination of the left pylon aft mount lug fractures found evidence of fatigue cracks in addition to areas of overstress failure. On the aft lug, on both the inboard and outboard fracture surfaces, a fatigue crack was observed where the aft lug bore met the aft lug forward face. For the forward lug's inboard fracture surface, fatigue cracks were observed along the lug bore. For the forward lug's outboard fracture surface, the fracture consisted entirely of overstress with no indications of fatigue cracking. The forward top flange of the aft mount assembly was examined for indications of deformation or pre-existing fractures, but no indications were found. The spherical bearing was removed from the wing clevis for further evaluation (see figure 10).

**Figure 10.** The spherical bearing and attachment hardware after removal from the left wing clevis.
